Manhole Inspection Summary

Manhole # S23UU1029MH

Record Plat: **23UU1** Node: **029** Status: **New Manhole (Not in GIS)** Insp Date: **11/30/06 12:00 AM**

Location Address: **1 HARVEST RD** Cross Street: **EDGEVALE RD**

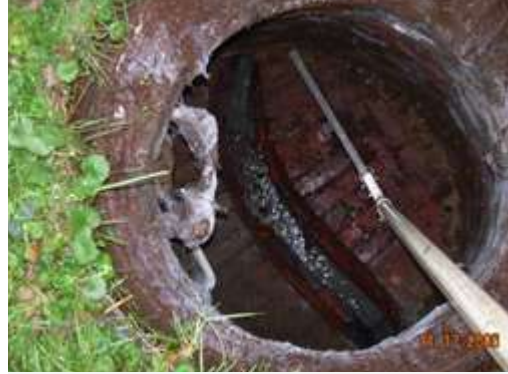
Top View

Corroded steps. Evidence of surcharge - Bench debris. Channel debris.

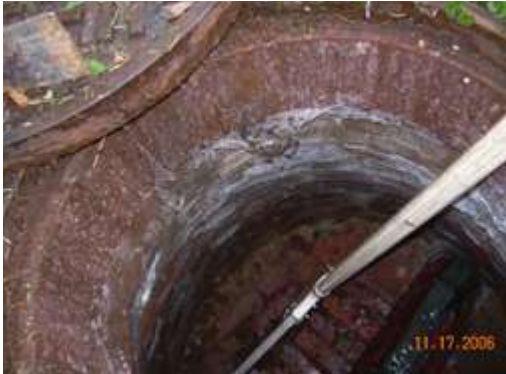
Defect

Adjustment, Corbel and Barrel infiltration.

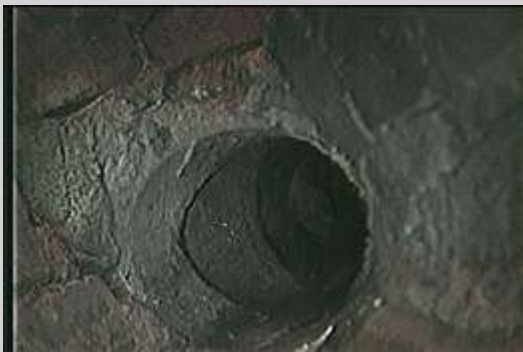
6 in. Circular Gravity Sewer Pipe Out @ 12 O'Clock

Infiltration: **Evidence** Pipe Seal Cond: **Cracked**

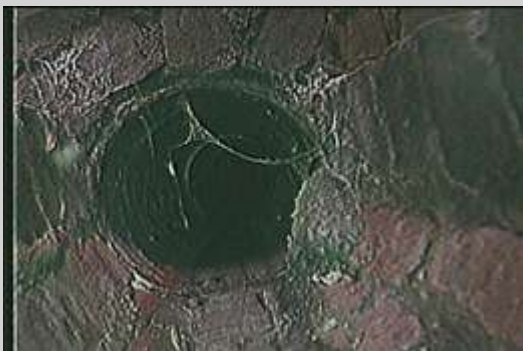
8 in. Circular Gravity Sewer Pipe In @ 4 O'Clock

Channel root intrusion.

Infiltration: **Evidence** Pipe Seal Cond: **Cracked**
